# Multi-Index Evaluation of Flexible Pavement Performance: A Comparative Analysis of PCI, IRI, and SDI Approaches

Juang Akbardin, Fahira Cindikiawati, Dadang Mohamad Ma'soem

Program Studi Teknik Sipil, Universitas Pendidikan Indonesia, Bandung, INDONESIA

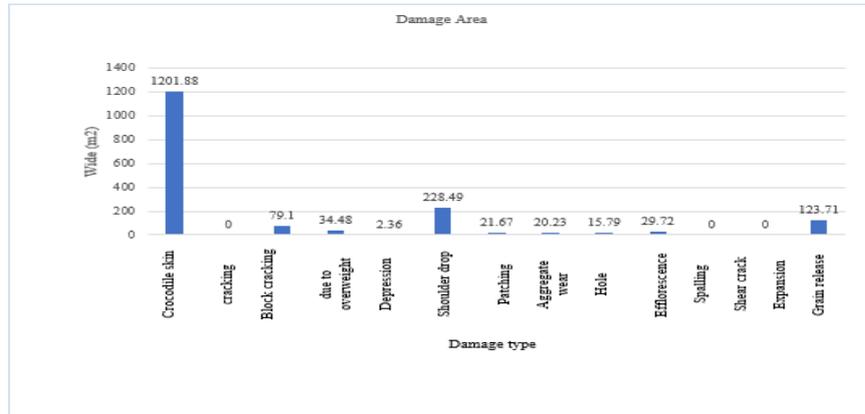
Figure 2. Summary of Damage Area Source: 2023 Research

The results of the road damage digitization revealed that the largest damage volumes were crocodile skin cracks, covering 1,201.88 m<sup>2</sup>, and patches, covering 228.49 m<sup>2</sup>. The longest total damage length was longitudinal cracks, measuring 731.69 m.

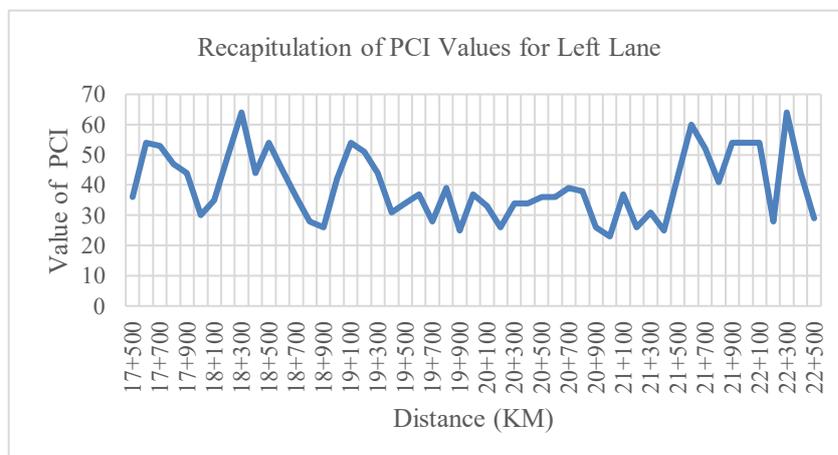
Figure 4. Recapitulation of PCI Values for the Left Lane Source: 2023 Research

In the left lane, the lowest PCI value was 23 at KM 21+000. The highest PCI value was 64 at KM 18+300 and 22+300. In the right lane, the lowest PCI value was 23 at KM 21+000. The highest PCI value was 64 at KM 18+300 and 22+300. In the right lane, the lowest PCI value was 18 at KM 18+600. The highest PCI value was 68 at KM 21+600.

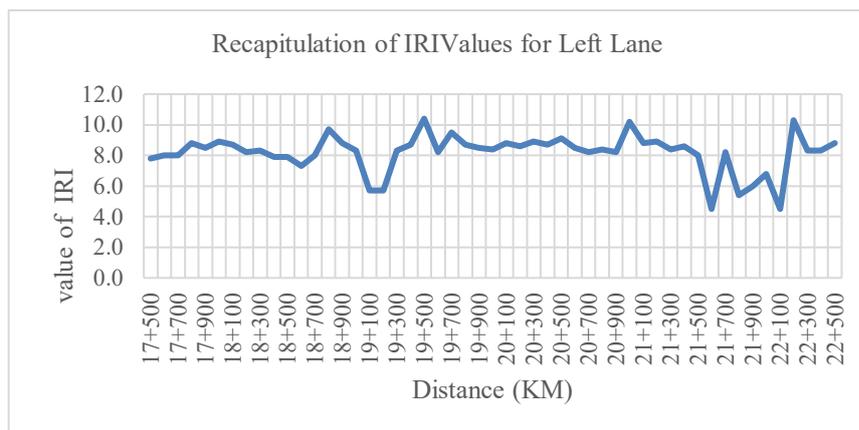
Figure 6. Summary of IRI Values for the Left Lane Source: 2023 Research

In the left lane, the lowest IRI value was 4.5 at KM 21+600 and KM 22+100. The highest IRI value was 10.4 at KM 19+500. In the right lane, the lowest IRI value was 3.4 at KM 20+600. The highest IRI value was 12.2 at KM 19+300.

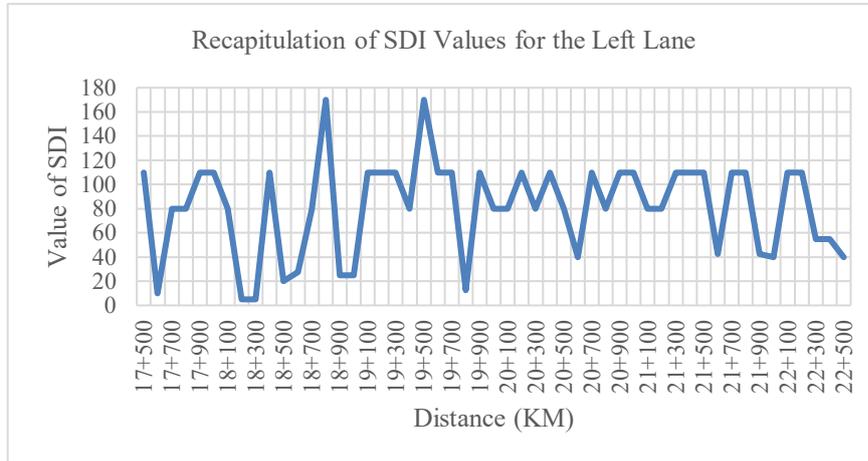
**Figure 8.** Summary of Left Lane Traffic Values Source: 2023 Research

In the SDI method, the lowest SDI value for the left lane was 5 at km 18+200, 18+300, and 18+500. The highest SDI value was 170 at km 18+800 and 19+500. For the right lane, the lowest SDI value was 0 at km 21+600. Meanwhile, for the right lane, the highest SDI value was 155 at km 21+400.

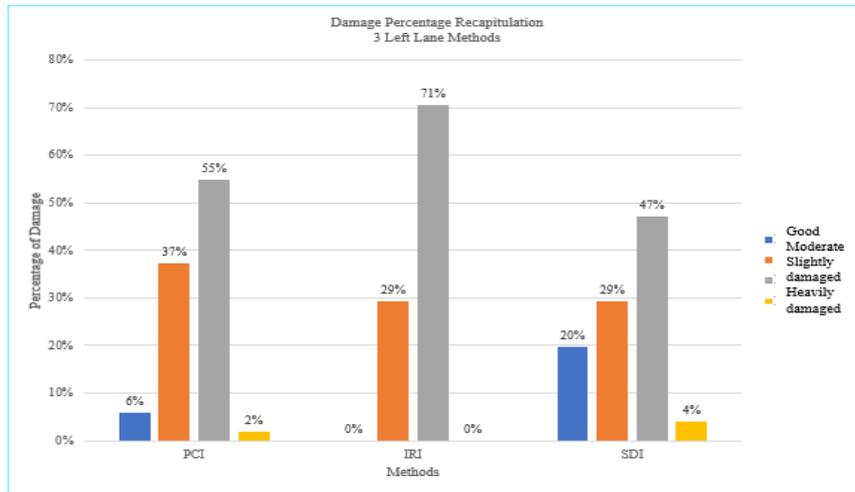
Figure 10. Summary of Left Lane Damage Levels Source: 2023 Research

The results of determining the level of road damage using the PCI, IRI, and SDI methods yielded the same highest level of damage, namely Minor Damage. The percentage summary is presented in Figures 10 and 11.

With the high percentage of light damage, road improvement efforts are needed to restore the road's stability. Road improvements can be achieved by adding an asphalt layer/overlay.

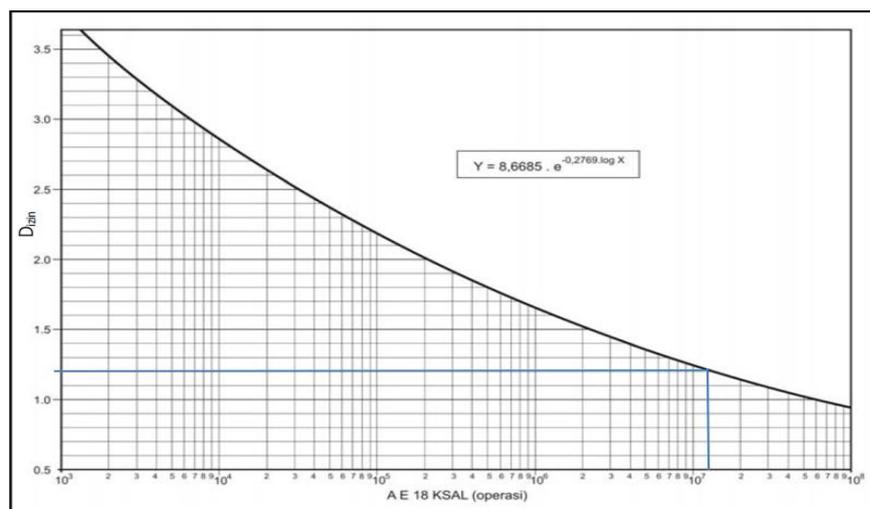
Figure 12. Allowable Back Deflection Source: 2023 Research Results

The calculation of the allowable back deflection (D) is performed by plotting the CESA value on the following allowable back deflection graph:

Therefore, the allowable deflection obtained is 1.2 mm.
