Analysis of Secondary Local Road Conditions Using the Surface Distress Index (SDI) Method in Medan Amplas District

Edo Rizki Pradana Lubis, Gina Cynthia Raphita Hasibuan, M. Ridwan Anas

Magister Teknik Sipil Universitas Sumatera Utara, Medan, INDONESIA

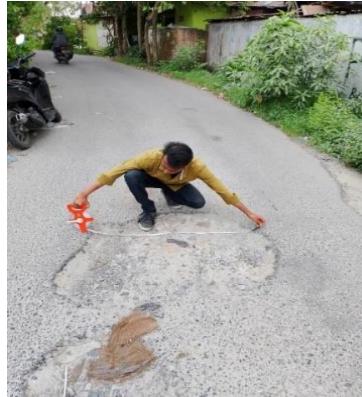
Figure 5. STA 0+200

Limitation of Damage Level calculations using the Surface Distress Index (SDI) method, namely there is a calculation of the number of holes in the SDI calculation. Meanwhile, in field conditions, if only the number of holes is calculated, according to the author, it does not have a significant effect on the calculation of the damage value. For example, there is a case on the Sungai Denai Inspection

Road, where at Sta 0+200 to Sta 0+300 there is a hole size that is quite badly damaged but to calculate the number of holes there is 1 hole and it can be seen in the following picture:

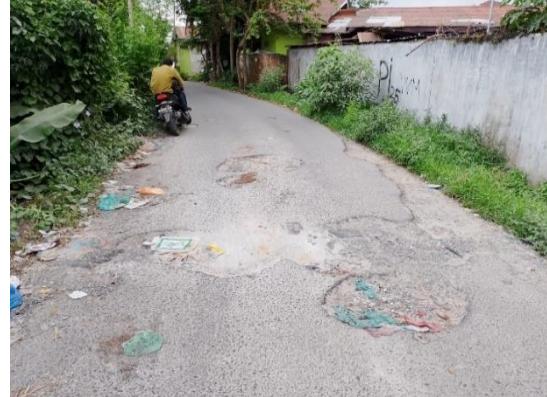
Figure 6. Condition STA 0+200 to STA 0+300
