Seismic Vulnerability Assessment of Plaza Bogor Building in Bogor City

Muhamad Lutfi, Nurul Chayati, Indra Mulyana, Muhammad Khaerul Insan

Civil Engineering Department at Ibn Khaldun University Bogor, INDONESIA

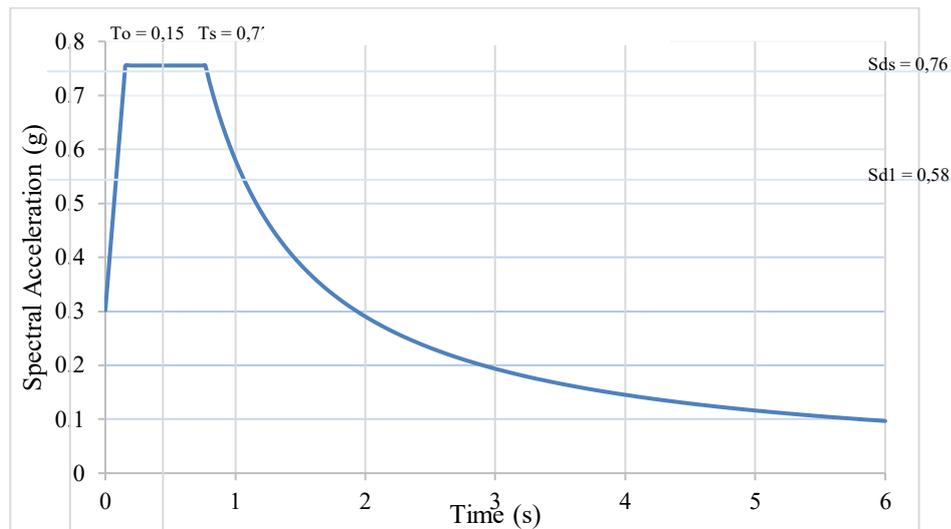
Figure 3. Acceleration spectral graph (g) (Source: RSA software, 2021)

The risk category for the Plaza Bogor Building is II and the seismic design category is D. So that the seismic force bearing system can be determined based on Table 12 - SNI 1726:2019 including the Special Moment Bearing Frame System (SRPMK). The following summary of seismic force bearing system data for the Bogor Plaza Building is shown in Table 5.

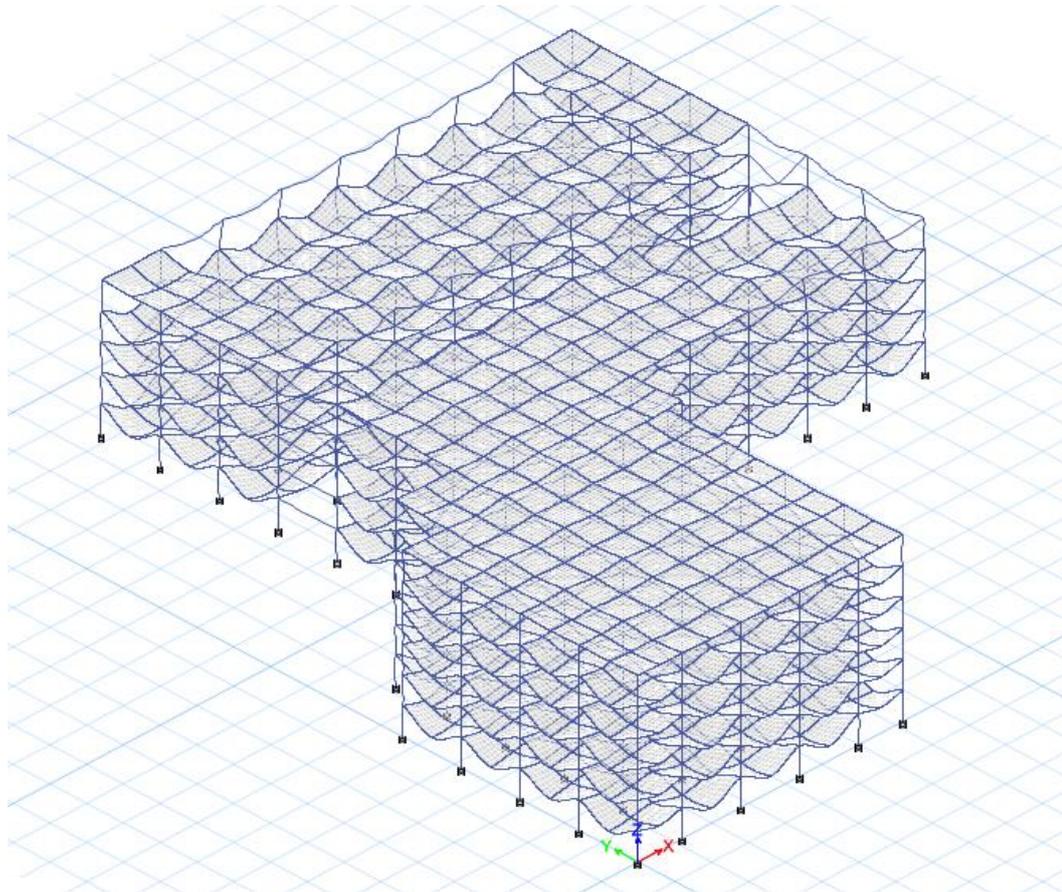
Figure 4. Results of dead load displacements (Source: Analysis result)

After all the loadings have been inputted in the ETABS software, where each loading is inputted, the structure that has been designed can be carried out at the next stage, namely the run analysis stage shown in Figure 4.

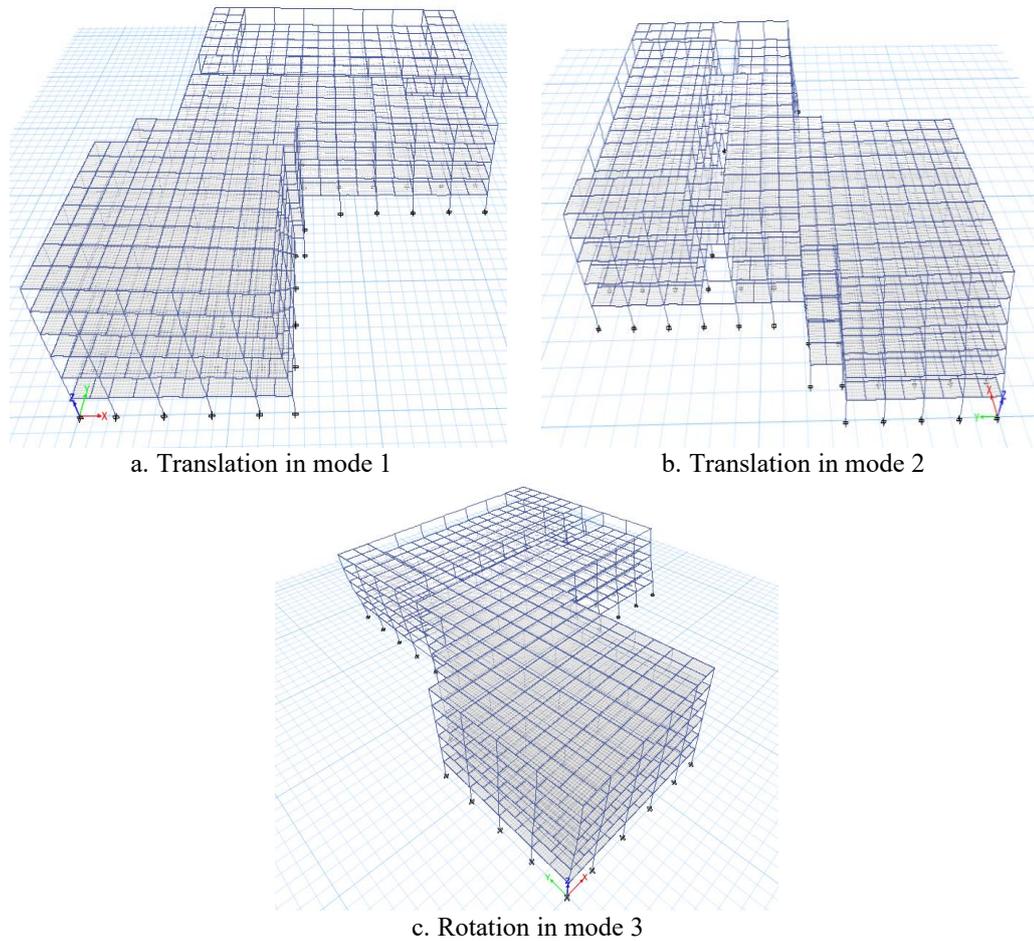
Figure 5. Vibration mode patterns of the building structure (Source: Analysis result)

In Figure 5a that has been presented, we can see the vibration pattern (mode 1) of the building structure that is translated towards the x-axis with a period of 1,601 seconds. Figure 5b is a pattern of vibration (mode 2) in the structure of the building that experiences translation towards the y-axis with a period of 1,487 seconds. While in Figure 5c is a pattern of vibration (mode 3) in the structure of the building that undergoes rotation towards the z-axis with a period of 1,381 seconds. So that the shape of the variation pattern meets the standards for stiffness in building structures.
