## Assessment of Building Seismic Risk in the Environment of Ibn Khaldun University Bogor

Muhamad Lutfi, Nurul Chayati, Rulhendri Rulhendri, Denny Azhari

Civil Engineering Departement Ibn Khaldun University Bogor, INDONESIA

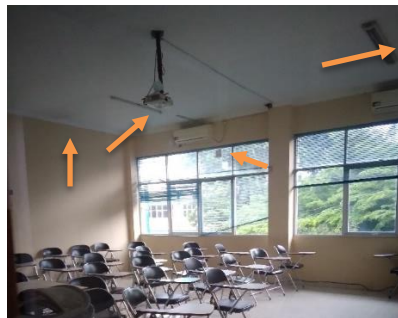
Figure 5. Structural and Falling Hazard Elements

Based on Figure 5, all the evaluated buildings have non-structural factors that are harmful to building users in the event of a shock from the subgrade or an earthquake. In the evaluation, there were several falling hazard elements that were evaluated, such as ceilings, LCD projectors, fans, and lighting lamps attached to the ceiling in almost the entire room. Vertical irregularity in buildings is classified as a split level category on the roof of the building as shown in Figure 6, this condition occurs in 3 buildings in UIKA Bogor. Plan irregularities occur in 1 building that is classified as L-shaped on the building plan as shown in Figure 7 above. The buildings in UIKA Bogor that were selected in this study were built after the existence of national standard rules, so that the buildings in the UIKA Bogor environment were built with standard regulations for earthquake resistance planning for building structures (SNI 1726-2002)

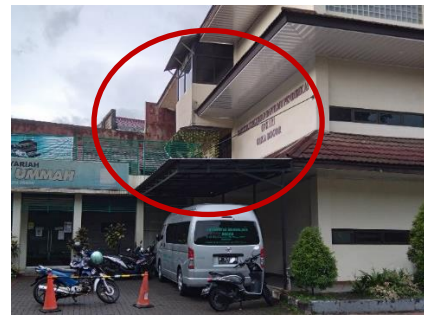
Figure 6. Split level in the DR building. H. Marzoeki Mahdi

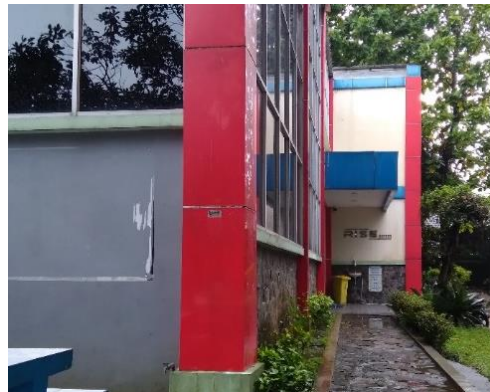
Figure 7. Shaped in the Riise Center building
