The Reliability Level of Women's Dormitory Building Ibn Khaldun University Bogor

Muhamad Lutfi, Nurul Chayati, Rulhendri Rulhendri, Reska Ariyanti, Muhammad Khaerul
Insan

Program Studi Teknik Sipil, Universitas Ibn Khaldun Bogor, INDONESIA

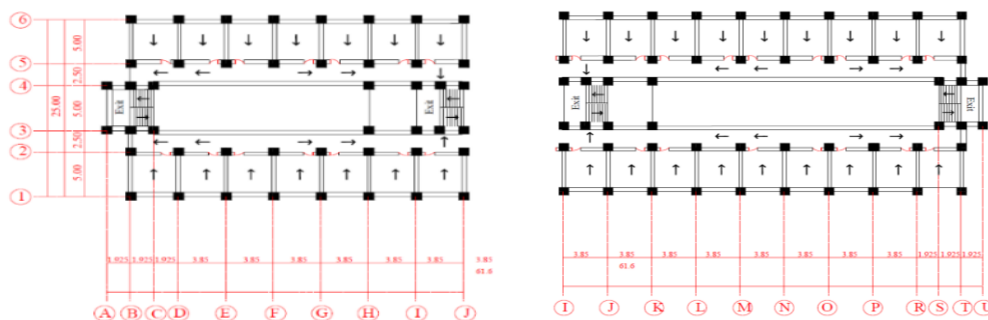
Figure 4. Evacuation Route Plan

Several fire prevention systems are not available such as sprinklers and gas extinguishers thereby reducing the percentage, thus the ASPIKA Building has a value of 65% of 100%, which indicates "Less Reliable", due to the score of the fire prevention system is not maintained and is prone to damage to the utility percentage value and fire protection are shown in Table 5.

The plan to increase the reliability of utilities and fire protection according to SNI 03-1746-2000 and Permen PU No.26 of 2008 is the addition of fire prevention systems such as; fire alarms, sprinklers, gas extinguishers, and evacuation routes. Evacuation routes that have been equipped with signs make it easier for building occupants to be directed and not panic when a fire occurs, as shown in Figure 5. The sprinkler installed on the ASPIKA building is in accordance with Figure 6. This is the safest sprinkler installation plan, namely placing it at every point trigger fire or flammable materials, avoid the fire that is getting bigger.
