DETERMINING ROAD HANDLING ACCORDING TO THE LEVEL OF DAMAGE USING SURFACE DISTRESS INDEX (SDI) METHOD (Case study on Jl. Merdeka 1 Sukabumi City)

Paikun Paikun, Elis Suminar, Aldi Irawan, Saiful Bahri Civil Engineering Departement, Nusa Putra University, INDONESIA E-mail: <u>paikun@nusaputra.ac.id</u>, <u>elis.suminar ts17@nusaputra.ac.id</u>

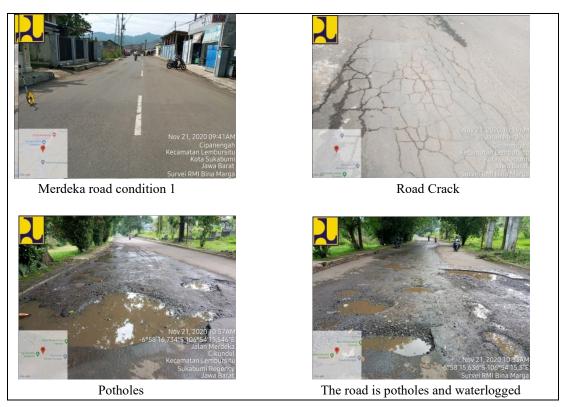
Figure 3. Condition of Jl. Merdeka 1 Sukabumi city

The basis for determining the location of the object of research on Jl. Merdeka 1 Sukabumi City, because this road is accessed from the area to the city, access to shopping places, access to government offices, and there are also road damage. Description of road conditions as shown in Figure 3.

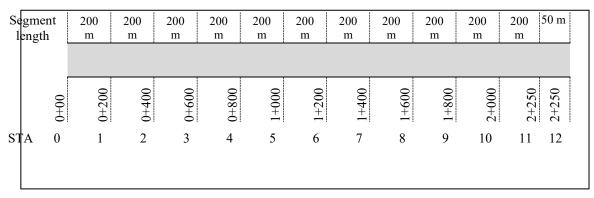
Figure 4. The data on road damage using the StreetMap method

Data collection on road conditions in this study is a must. The collection of data on road conditions includes the number of cracks, the area of the cracks, the thickness of the cracks, the number of holes, and the damage to vehicle ruts. The road damage data collection uses the StreetMap method, which is to divide the segment by 200 m in length per segment, and the width using the average width because the width of the road for each segment is different. Stationing position (STA) 0 + 000 starting from the intersection of Jalan Pelabuhan 2 and the final STA position on Jl. Merdeka 2. Segment division scheme as illustrated in Figure 4 below.

Based on the results of surveys and investigations as a schematic in Figure 4, it is known that road conditions consist of cracks, holes, and damage by vehicle wheels. The road damage then

becomes quantitative data consisting of the number of cracks, crack area, crack thickness, the number of holes, and the number of holes caused by vehicle wheels. This quantitative data then analyzed using the Surface Distress Index (SDI) method.

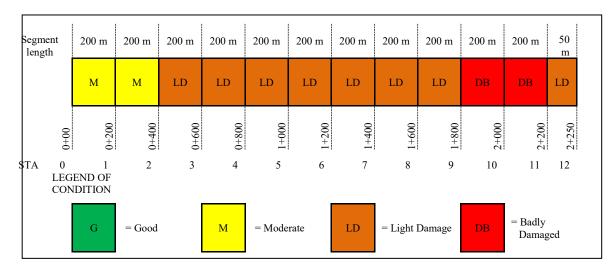
Figure 5. StreetMap method. Damage to the road on Jl. Merdeka 1

The StreetMap method is used as a pattern for conducting research data collection for each segment, facilitating the explanation of the interpretation of the SDI analysis results, and finding out points of road conditions that require maintenance, rehabilitation, and reconstruction. The results of the road mapping for each segment based on the results of SDI analysis are described in figure 5 below.

Research to determine the condition of road damage on Jl. Merdeka 1 Sukabumi city uses the Surface Distress Index (SDI) method, then visualized using the Street Map method it can be interpreted that at STA 0 + 00 - 0 + 400 along 400 m the condition is moderately damaged and requires maintenance. The conditions of STA 0 + 400 - 1 + 800 and STA 2 + 200 - 2 + 250 along 1,450 m are slightly damaged and require rehabilitation. The condition of STA 1 + 800 - 2 + 200 along 400 m was badly damaged and needed reconstruction. Based on data collection and analysis in this study, it can be used as a basis for decision-making by road policymakers and managers to carry out road handling. Furthermore, it is necessary to estimate costs to find out the amount of the budget required.

The results of the analysis of the Surface Distress Index (SDI) method are shown in Table 6. It is known that the condition of Jl. Merdeka 1, Sukabumi city is in moderate condition, slightly damaged and heavily damaged in the respective STA segment. Therefore, it can be seen the appropriate type of treatment for each segment as suggested in Table 7 below.

Table 7 explains the road damage category on Jl. Merdeka 1 Sukabumi City, as well as suggestions for proper road damage handling based on the SDI method. To visually understand the location points of the requiring further maintenance, rehabilitation and reconstruction should be submitted using the StreetMap method.
