Analysis of Road Damage Levels Using the SDI (Surface Distress Index) Method for Evaluation and Handling of Potholes

Muhammad Nanang Prayudyanto, Rulhendri Rulhendri, Syaiful Syaiful,
Riki Natanael Ramadan

Civil Engineering Departement, Ibn Khaldun University, Bogor, INDONESIA

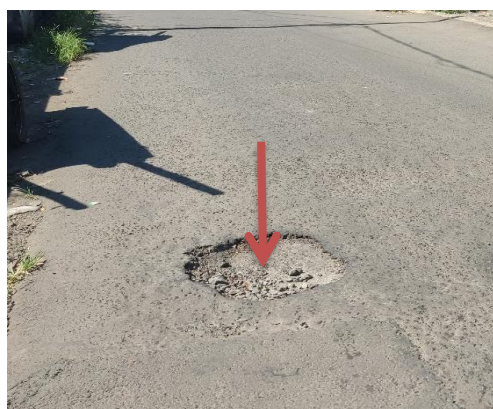
Figure 5. Holes (Source: Research Results)

Figure 5 shows documentation of the type of damage that occurred on the flexible pavement on Jalan Ciremai Ujung, namely holes caused by a poor mixture of surface layer material and traffic loads which resulted in the release of surface layer material.

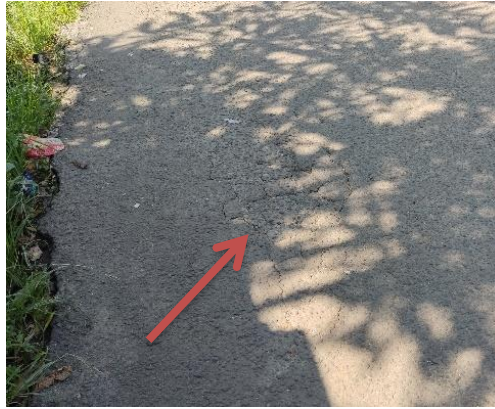
Figure 6. Cracking (Source: Research Results)

Figure 6 shows documentation of the type of damage that occurred on the flexible pavement on Jalan Ciremai Ujung, namely cracking caused by poor pavement materials and the tensile stress that occurs in the asphalt layer exceeds the maximum tensile stress that the pavement can withstand.

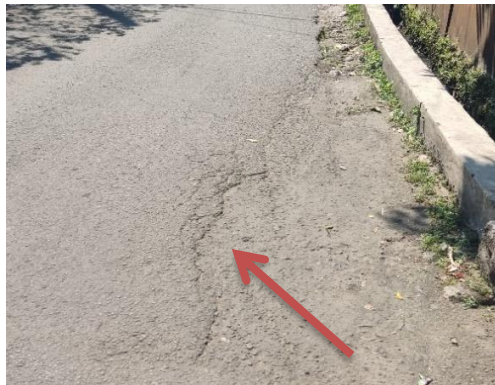
Figure 8. Side Cracks (Source: Research Results)

Figure 7 shows documentation of the types of damage that occurred on the flexible pavement on Jalan Ciremai Ujung, namely side cracks caused by poor support from the side, poor drainage, and soil shrinkage.

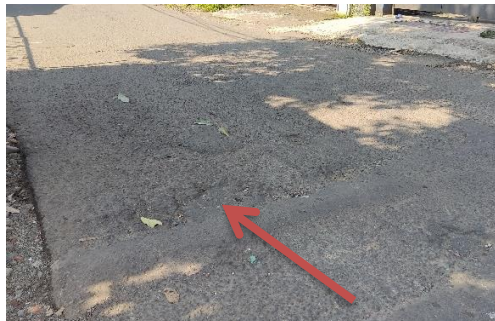
Figure 9. Peeling of the Surface Layer (Source: Research Results)

Figure 9 shows documentation of the type of damage that occurred on the flexible pavement on Jalan Ciremai Ujung, namely peeling of the surface layer caused by a lack of bond between the surface layer and the layer beneath it or the surface layer being too thin.

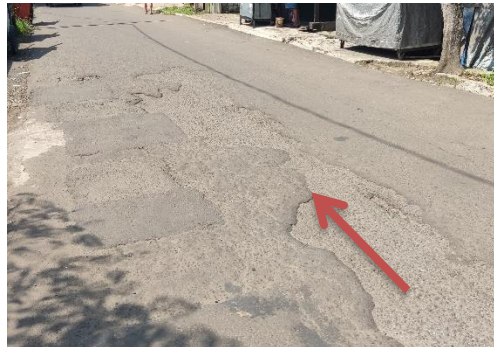
Figure 10. Grain Release (Source: Research Results)

Figure 9 shows documentation of the type of damage that occurred on the flexible pavement on Jalan Ciremai Ujung, namely the release of grains due to the reduction or loss of the sticky power of the

asphalt binder, so the rock grains began to come off, the road surface became rough, had holes and leaked water.

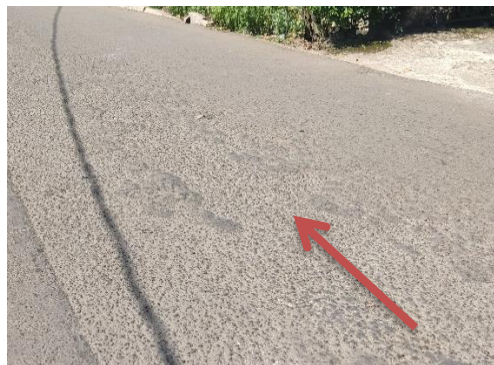
Figure 11. Wear and tear (Source: Research Results)

Figure 10 shows documentation of the type of damage that occurred on the flexible pavement on Jalan Ciremai Ujung, namely wear caused by aggregates made from materials that are not resistant to wear and tear from vehicle wheels or the aggregates used are round in shape and result in the road becoming slippery.

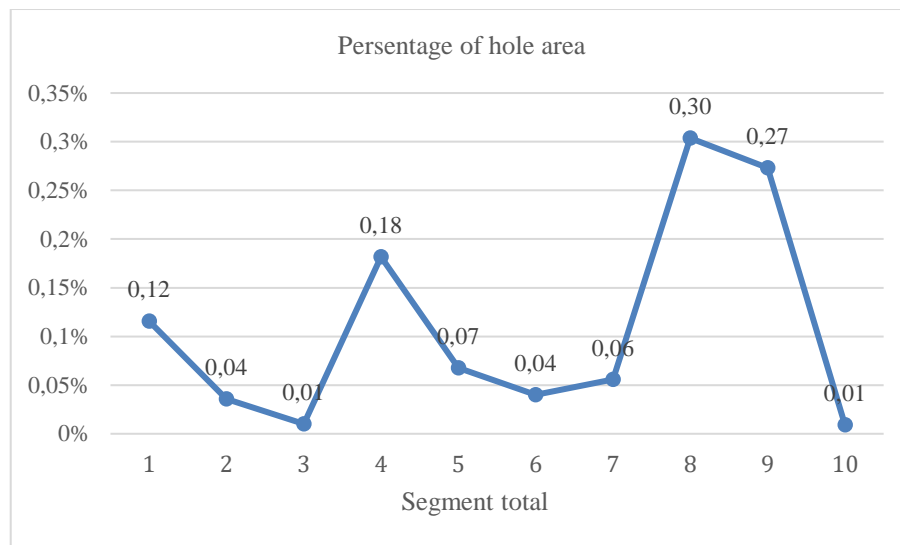
Figure 12. Percentage of Hole Area (Source: Analysis results)

The results of the percentage of potholes in the 10 segments have different % values, where the largest percentage of potholes is in segment 8, namely 0.30% with a total of 3 holes and the smallest in segment 3 and segment 10, namely 0.01% with the number of holes is 2 holes. The following is a graph of the percentage of hole area on the damaged Ciremai Edge road which can be seen in Figure 12 below:
