Analysis of Pedestrian Satisfaction toward the Repurposing of Sidewalks along Muara Karang Raya Street

Fernando Donica Yandrie¹, Nunung Widyaningsih²

¹Civil Engineering Department, University of Mercu Buana, Jakarta, INDONESIA

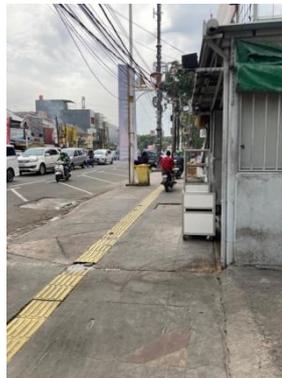
Figure 3. Street Vendor's Cart on the Sidewalk

Figure 3 shows that some of the Muara Karang Raya sidewalks are being used as trading areas by local individuals. Observations indicate that vendors are using portions of the sidewalks to set up carts, tents, and even tables. This, of course, makes pedestrian space narrower than it should be. As a result, pedestrians are forced to walk along the edge of the road or even onto the roadway, which not only reduces road user comfort but also increases the risk of accidents. This phenomenon demonstrates the conflict between economic needs and road users' rights to infrastructure, which should be a priority.

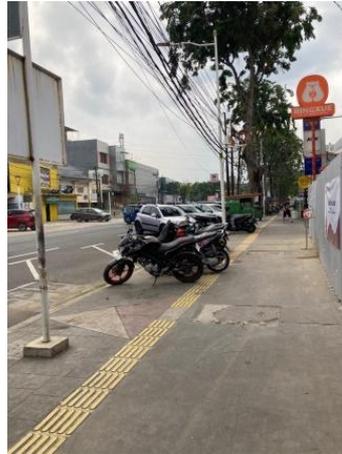
Figure 4. Illegal Parking on the Muara Karang Raya Sidewalk

Not only the presence of street vendors, illegal parking on the sidewalk also narrows the space for pedestrians, it can be seen in Figure 4 that almost all of the sidewalk is used to park their private vehicles, some of these vehicles even block the road facilities for the blind. With the physical limitations of blind people who do not know for sure what the conditions in front of them are, this illegal parking incident is certainly very disturbing and even threatens safety.

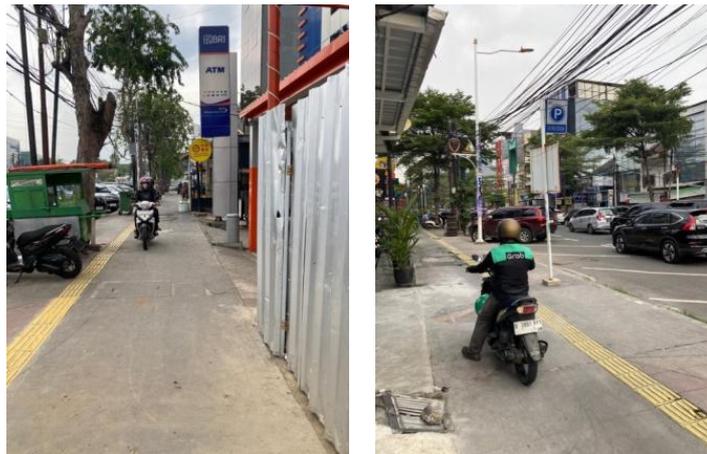
Figure 5. Online Motorcycle Taxi Activities on the Muara Karang Raya Sidewalk

This situation is exacerbated by the presence of unscrupulous online motorcycle taxi drivers, who frequently use sidewalks as waiting areas for passengers, dropping off passengers, and even as a pedestrian crossing. Unscrupulous online motorcycle taxi drivers use sidewalks to bypass traffic or avoid traffic jams, potentially endangering pedestrians, especially children and the elderly. Furthermore, the habit of online motorcycle taxis waiting for passengers at the edge of sidewalks also narrows the roadway, ultimately disrupting the comfort of road users.

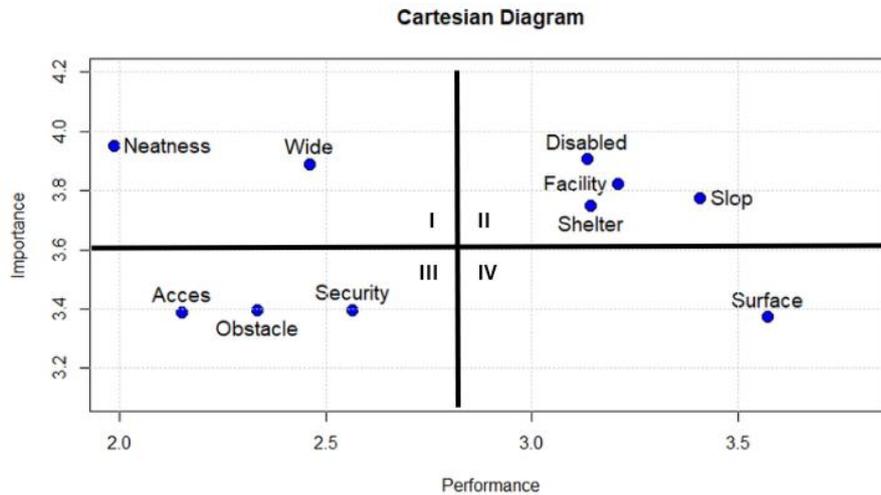
Figure 6. Cartesian diagram

Based on Figure 6 above, the results can be obtained

1. Quadrant I (Sidewalk facilities are the main priority)
 - a. Sidewalk width indicator.
 - b. Indicators of order on pedestrian paths (street vendors, illegal parking, etc.).
2. Quadrant II (Sidewalk facilities whose performance must be maintained)
 - a. Indicators of the availability of facilities for the disabled and the elderly.
 - b. Slope and gradient indicators.
 - c. Shelter availability indicator
 - d. Seating indicators, trash bins, signs and lighting.
3. Quadrant III (Sidewalk facilities to be considered)
 - a. Accessibility indicators from & to the route
 - b. Safety indicators for pedestrians
 - c. Obstacle indicators around the sidewalk (Flower pots, electric poles)
4. Quadrant IV (Excessive sidewalk facilities)
 - a. Indicator of sidewalk surface condition (neatness and regularity).

The average performance and importance ratings were obtained by dividing the total score for each item by the number of respondents. This average score was then distributed into a Cartesian diagram, where each point represents the condition of the Muara Karang Raya sidewalk facilities.
