Evaluation of Pilot Ladder Safety Systems Using a Checklist Approach: Case Study on MV Westerdam and MV Hao Qiang 57 at Tanjung Perak Port

Narko Narko, Slamet Imam Wahyudi, Juny Andry Sulisty

Master of Civil Engineering Program, Sultan Agung Islamic University, Semarang, INDONESIA

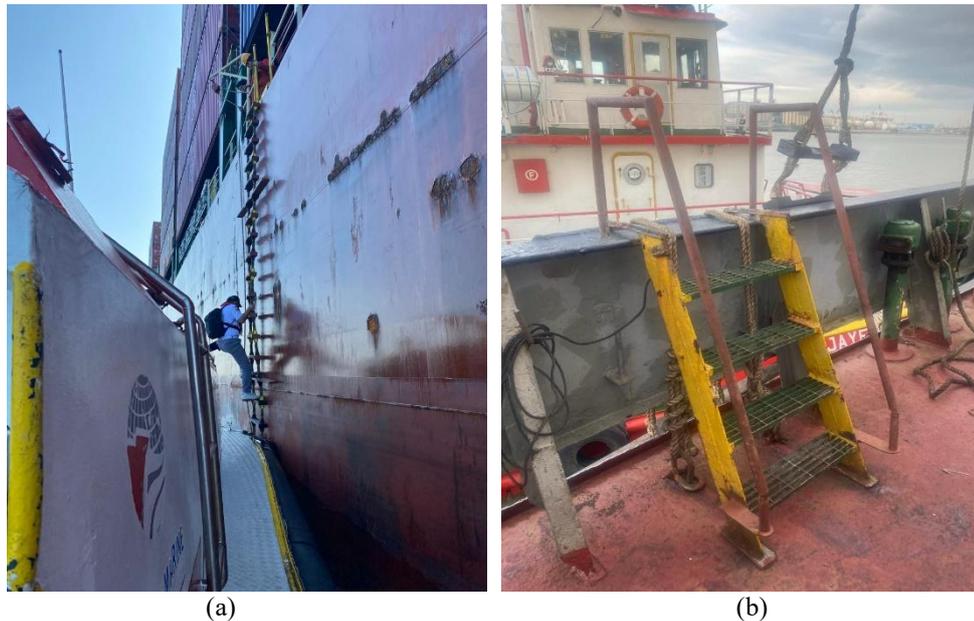
Figure 1. (a) Pilot boarding the ship using a pilot ladder; (b) Pilot ladder with handrails firmly attached to the main deck and hull of the ship

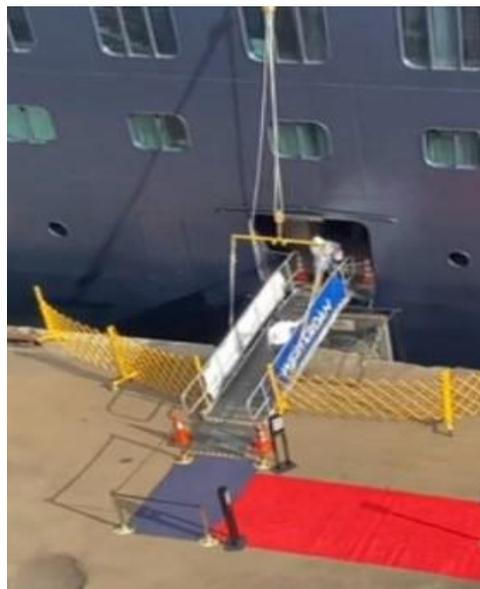
Figure 3 shows the MS Noordam's guide ladder when docked at the pier during the day. From the photo, it can be seen that the guide ladder access is equipped with a safe path, guardrails, and a red carpet that functions as a protocol path and emphasizes the boundaries of the safe area. This indicates the implementation of good safety standards, especially for passengers or important guests, although the main function is still intended for the guide officers. The orderly layout, flat surface in the dock area, and the presence of supervisory personnel around the ladder are supporting factors in creating a safe and controlled work environment. This observation is in line with the Safe Access to Ships principle in SOLAS V/23 regulation which emphasizes the importance of safe access to and from the ship [15], [9].

Figure 3. The MV Westerdam guide ladder while at the tanjung perak port pier in Surabaya

From the comparison of the two photos, it can be concluded that there are differences in the level of safety standards between MV Westerdam and MV Hao Qiang 57. MV Westerdam tends to pay more attention to visual aspects, comfort, and protocol procedures, while MV Hao Qiang 57 focuses more on functional aspects. However, in the context of pilotage safety, the implementation of K3 standards must be uniform, both for MV Hao Qiang 57 and passenger ships, because the risks faced remain the same.

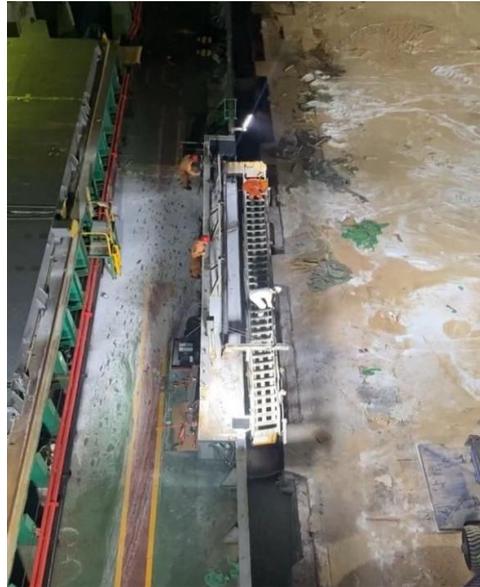
Figure 4 shows the MV Hao Qiang 57's gangplank at night, with additional lighting installed to ensure visibility. The photo shows the crew using the gangplank on the side of the ship, with a spotlight directed directly at the access area. Although lighting is available, it appears to be focused on the gangplank area only, while the surrounding area is relatively dark. This situation has the potential to be a safety weakness, as the deck area and the path around the gangplank should also be adequately lit to prevent potential accidents, especially during adverse weather conditions. This fact is in line with the findings in the checklist which states that lighting is one of the crucial aspects that needs to be improved, not only in terms of quantity (number of lights) but also light distribution.

Figure 4. The MV Hao Qiang 57 guide ladder at the Tanjung Perak harbor dock in Surabaya at night with lighting.

- On MV Hao Qiang 57, the physical condition of the stairs is relatively good, but deficiencies appear in supporting aspects such as limited lighting in the area around the stairs, even though spotlights are functioning at key points.
