Assessment of the Influence of Walkability Factors on Corridor Via VIII Febbraio and Via Roma in Padova, Italy

Michella Devina Hermawan, Gede Windu Laskara

Program Perencanaan dan Manajemen Pembangunan Desa dan Kota (PMDK) Program Magister
Arsitektur Universitas Udayana, Bali, INDONESIA

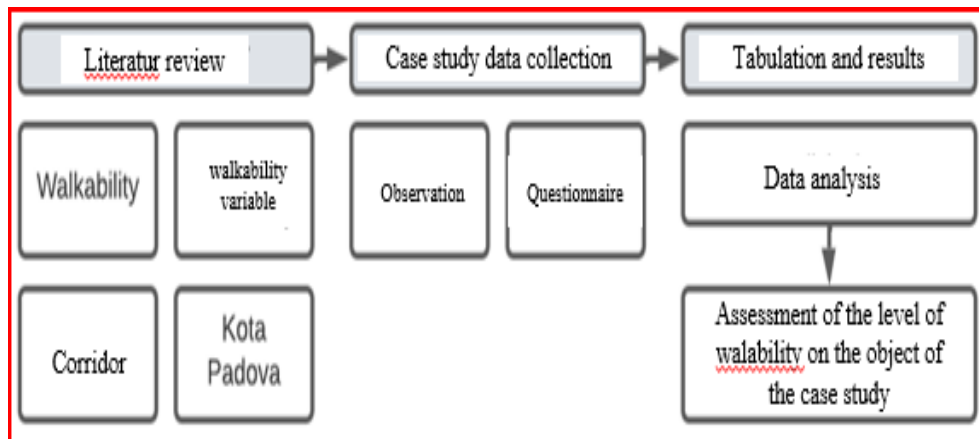
Figure 1. Diagram of research stages (Source: Personal Analysis, 2022)

1. Literature review to gain an understanding of walkability and to determine walkability indicators.
2. Primary observations in the historic center of the city of Padova to determine the positive and negative factors that contribute to, or reduce the quality of walkability. Direct observations were made with several visits to the Via VIII Febbraio and Via Roma corridors accompanied by documentation or taking photos. Surveys and observations help analyze pedestrian facilities and road elements and provide a primary data set on walkability level indicators.
3. Questionnaire; The questionnaire was used to reveal the perception of road users in the corridor of the object of observation. With a Likert scale, respondents can choose the option Strongly Agree (weight 5) to Strongly Disagree (weight 1).

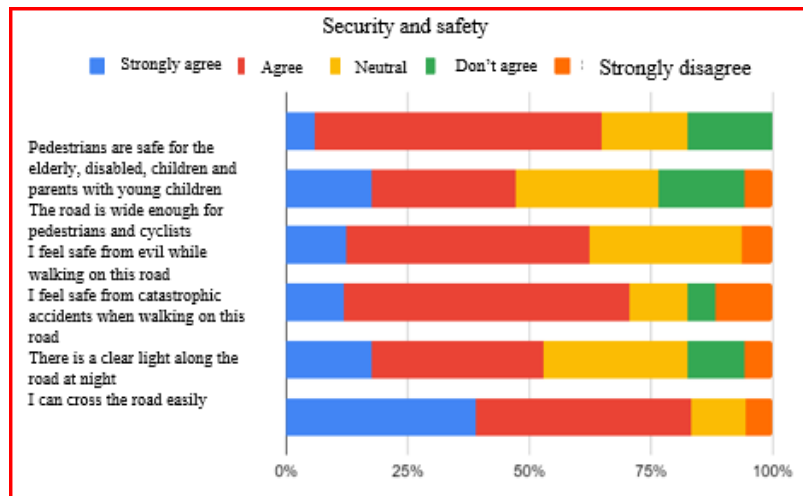
Figure 3. The results of the security & safety aspect survey (Source: Questionnaire, 2022)

The variable aspects of security and safety on foot on Via VIII Febbraio & Via Roma mostly have a fairly good score as a supporting factor for road walkability. The factor “the road is wide enough for pedestrians and motorists” gets the lowest score compared to other factors. This shows that some pedestrians feel uncomfortable with the presence of vehicles on a road which in fact is a pedestrian-only street, especially Via VIII Febbraio.

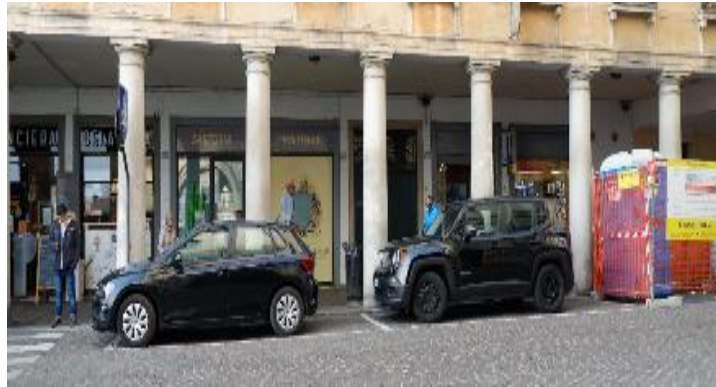
Figure 4. Parked vehicles (Source: Field observations, February 2022)

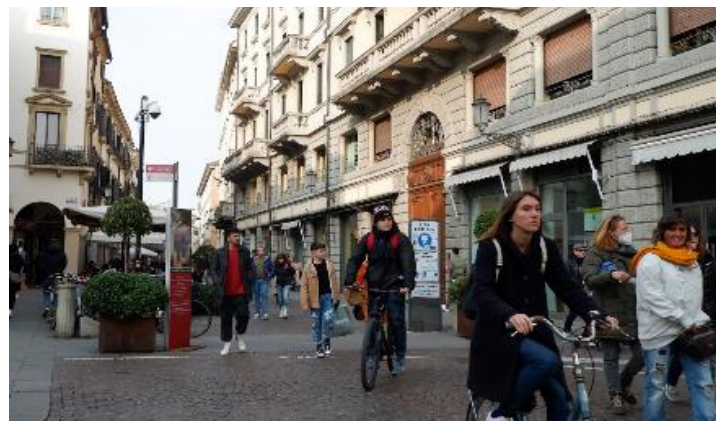
Some respondents admitted that they did not feel safe from accidents when walking in the corridor of the study object. The disaster in question is most likely in the form of a collision with a cyclist passing freely in the study object area, which can interfere with walking comfort.

Figure 5. The number of cyclists on the road (Source: Field observations, February 2022)

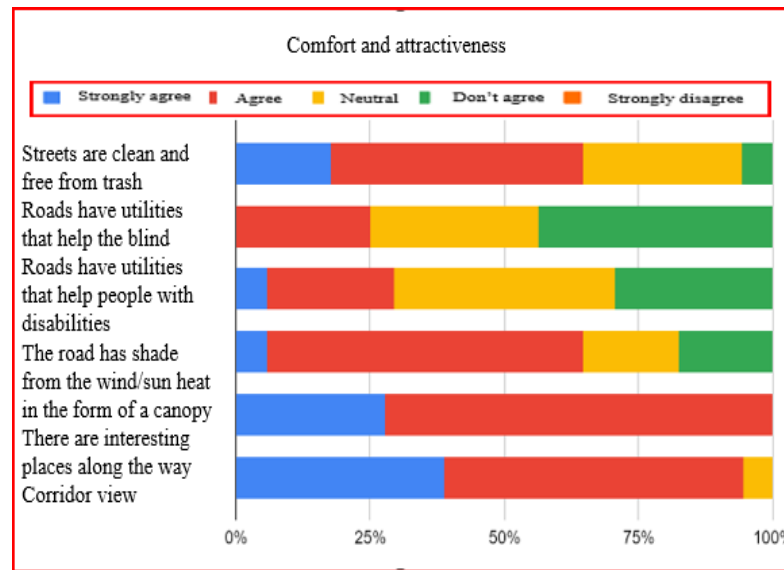
Figure 6. The results of a survey of comfort & attractiveness aspects (Source: Questionnaire, 2022)

Most pedestrians in the study area agree that the corridors are pleasing to the eye and there are many points of interest along the way. These two things are the main points that trigger the walkability factor in terms of comfort and attractiveness on Via VIII Febbraio & Via Roma Padova. On the other hand, many pedestrians feel that the facilities for the visually impaired and persons with disabilities in the study object are still inadequate. This needs to be considered in the future in order to support the needs of all pedestrians in an inclusive manner.

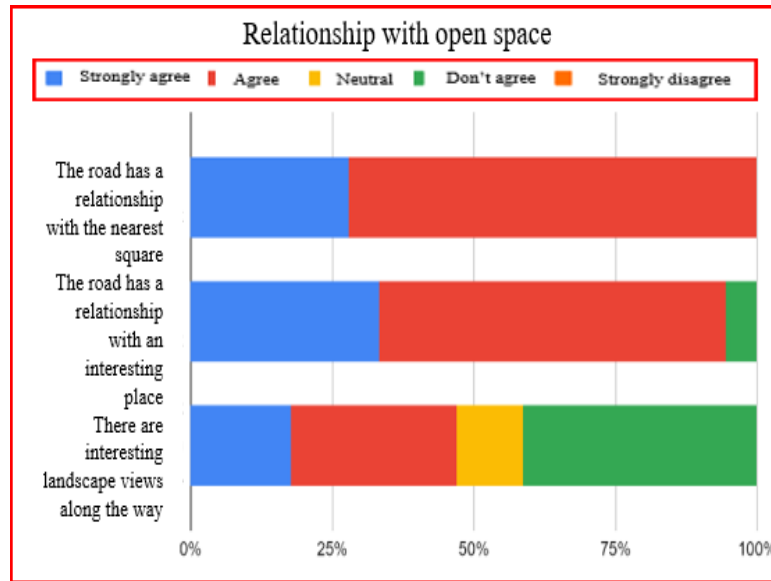
Figure 8. The results of the survey on the aspect of the relationship with open space (Source: Questionnaire, 2022)

Judging from the survey results, the statement that the road has a relationship with the nearest square gets a fairly high score with a figure of 85.5%. In addition, most pedestrians also admit that the object of study has a relationship with an interesting place, as evidenced by a score of 84.4%. There is a square or square called Piazza Cavour which is a public communal space near Via VIII Febbraio as a place to gather and interact casually. Unfortunately, there are not many landscape views along the promenade, and the majority of respondents agree with this statement. It can be concluded that the road does not have sufficient green open space, but its relation to the square and interesting objects also contributes to the walkability factor of the study object.

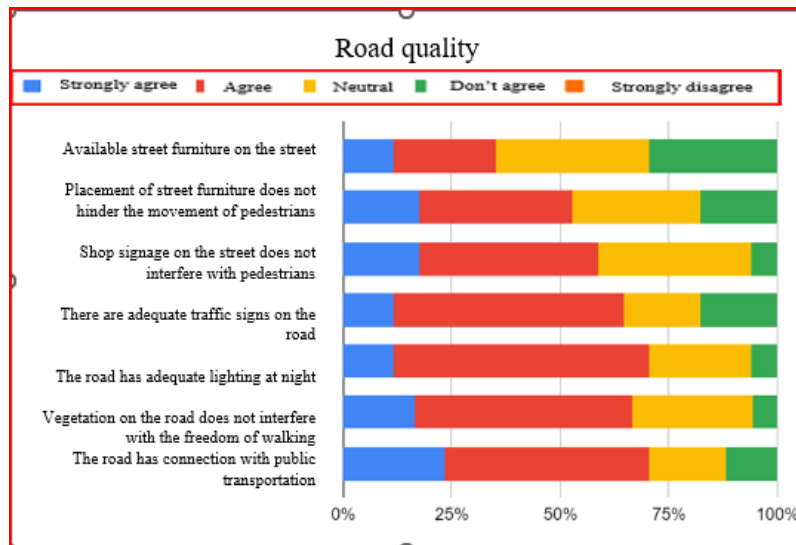
Figure 10. Survey results on road quality aspects (Source: Questionnaire, 2022)

The road quality aspect survey shows quite varied results. The road has several factors that are quite good to support the walkability of the object of study, although not all pedestrians have the same opinion. One of the factors found to be lacking in the aspect of road quality is the availability of street furniture along the road. Along the corridor, street furniture is only found in a small part of Via VIII Febbraio. This can be a consideration for stakeholders to increase the number of street furniture along the road in order to improve the quality of the road in the perception of pedestrians.

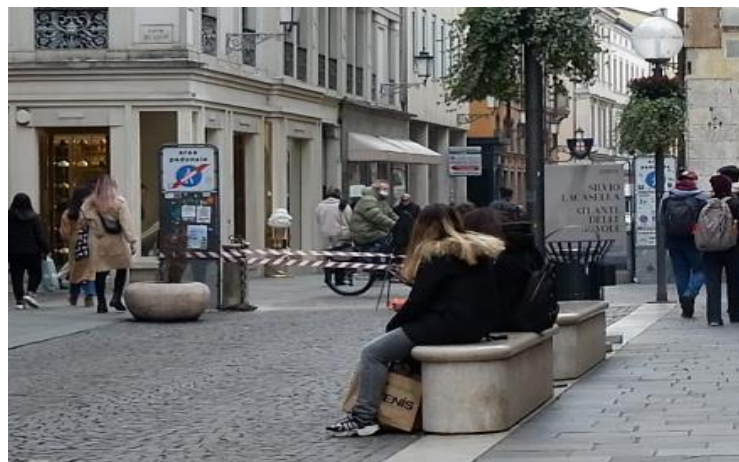
Figure 11. Bench on Via VIII Febbraio (Source: Field observations, February 2022)

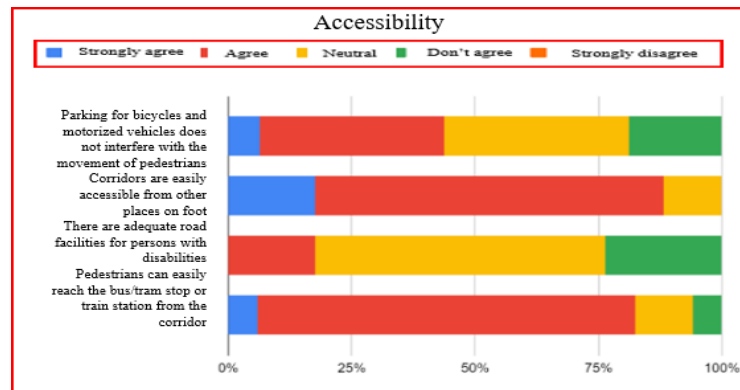
Figure 12. Accessibility aspect survey results (Source: Questionnaire, 2022)

Along the corridor, there are several bicycle parking points on the roadside. The road is also equipped with a bike lane on both segments. According to the survey results, some pedestrians feel disturbed by the existence of bicycle parking on the side of the road which also reduces the pedestrian area to be able to walk with full freedom. There are also several bicycles and cars parked on the side of the road. This is expected to be reduced in the future, in order to improve the walkability aspect in the study object area.

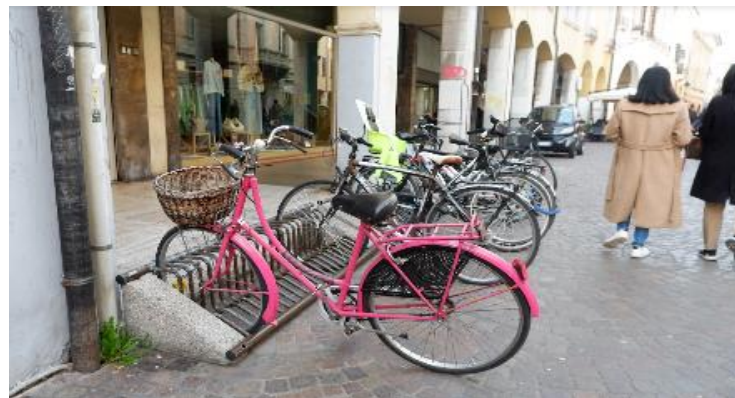
Figure 13. Bicycle parking (Source: Field observations, February 2022)
