Analysis of Secondary Local Road Conditions Using the Surface Distress Index (SDI) Method in Medan Amplas District

Edo Rizki Pradana Lubis, Gina Cynthia Raphita Hasibuan, M. Ridwan Anas

Magister Teknik Sipil Universitas Sumatera Utara, Medan, INDONESIA

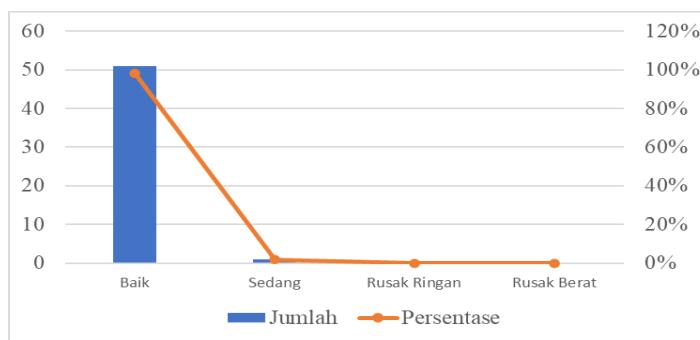
**Figure 4.** Barchart of Road Damage Levels

The level of road damage on Secondary Local Roads in Medan Amblas District is 98% (51 secondary local roads) in good condition and 2% (1 secondary local road) in fair condition. It can be concluded that the condition of the Secondary Local roads in Medan Amblas District is in good condition and only requires routine maintenance at certain points on each road section.
