## Assessment of Building Seismic Risk in the Environment of Ibn Khaldun University Bogor

Muhamad Lutfi, Nurul Chayati, Rulhendri Rulhendri, Denny Azhari

Civil Engineering Departement Ibn Khaldun University Bogor, INDONESIA

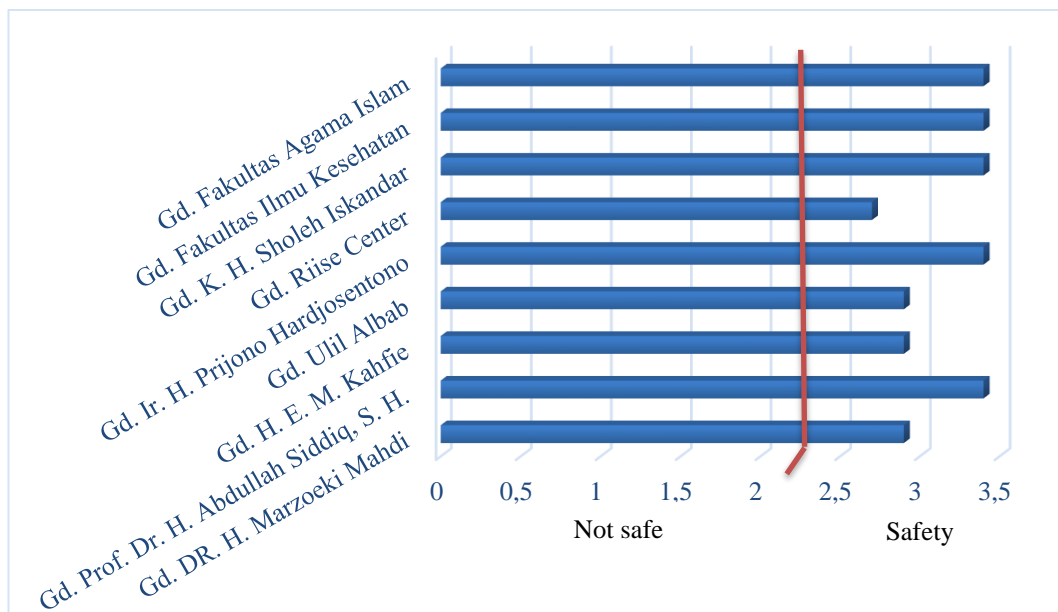
**Figure 8.** Graph of the final score of the vulnerability of buildings in the UIKA Bogor environment

From table 3 there are 5 buildings in UIKA Bogor that have the highest final score, namely the Prof. Dr. H. Abdullah Siddiq, S. H., Ir. H. Prijono Hardjosentono, K. H. Sholeh Iskandar building, Faculty of Health building and Faculty of Islamic Religion building with a final score of 3.4. The building that has the lowest final score is the Riise Center building with a final score of 2.7. even though it has the lowest final score of all buildings that have been researched, this value is still in accordance with the 2015 FEMA P-154 final score (SL1) regulation which has a minimum score of 0.5 so it is still classified as a safe building in the event of a shock or earthquake.
